# Manhole Inspection Summary

Manhole # S15SS1007MH

Insp Date: **12/1/06 9:55 AM**

**Location** Address: **CLYBURN AVE**

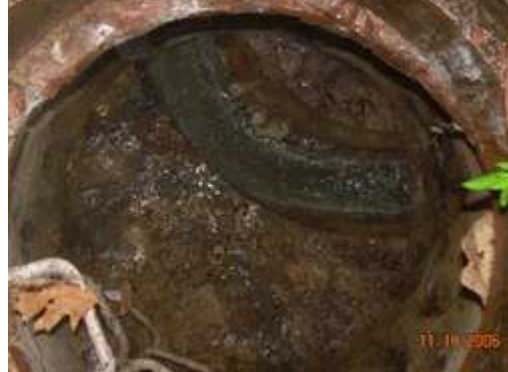
Top View

Frame offset. Evidence of surcharge - Bench debris.

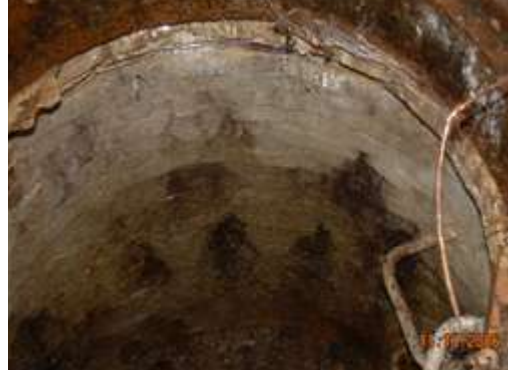
Defect

**Frame** Offset: **1** (in.) Condition: ☐ Sound ☐ Cracked ☒ **Leaks**

Condition: ☐ Sound ☐ Cracked ☐ Root Intrusion ☐ Loose Brick ☒ **Deteriorated**

Infiltration: ☐ None ☒ **Joint** ☐ Cracks ☒ **Mortar** ☐ Roots ☐ Wall

Frame leaks. Adjustment deterioration and infiltration. Corbel and Barrel infiltration.

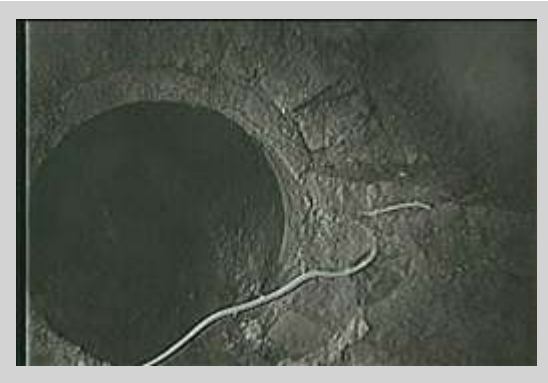
### 15 in. Circular Gravity Sewer Pipe Out @ 12 O'Clock

Barrel deterioration and infiltration. Channel deterioration.

Infiltration: **Evidence** Pipe Seal Cond: **Cracked**

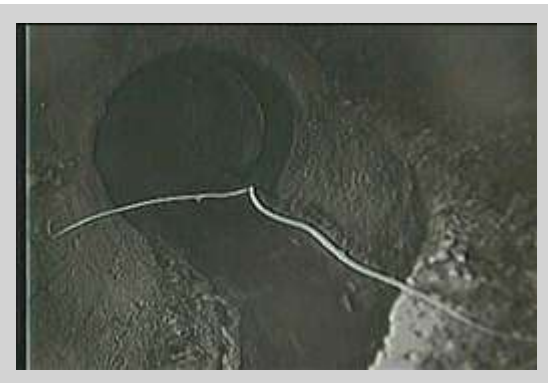
### 15 in. Circular Gravity Sewer Pipe In @ 4 O'Clock

Infiltration: **None** Pipe Seal Cond: **Unknown**
